Pipeline Inspection Report

Project: JUNCTION CITY COMMERCIAL
Work Order:
Survey Customer: WAY TO GO CONST.
PO Number:
Additional Info: 1INCH GRADE BALL & 8" MANDRELL

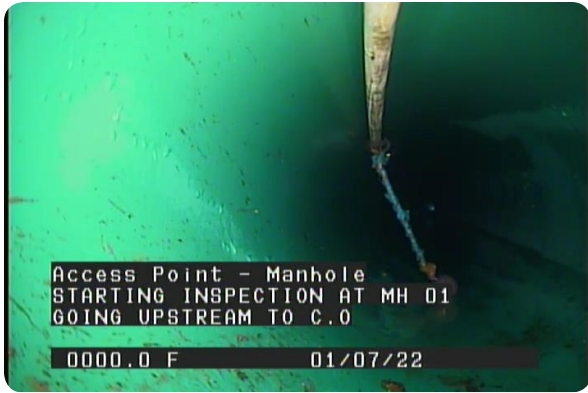
Access Point - Manhole at 000.0 feet | STARTING INSPECTION AT MH 01 GOING UPSTREAM TO CLEAN OUT

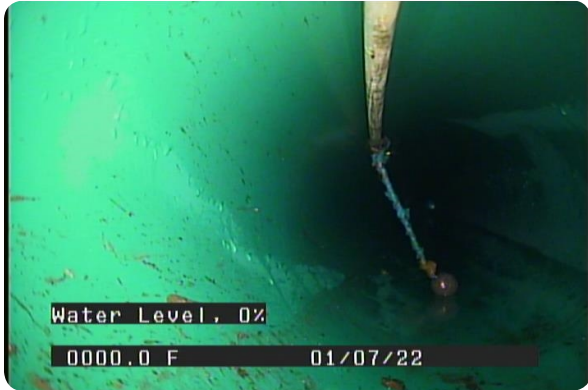
Water Level at 000.0 feet, 0%

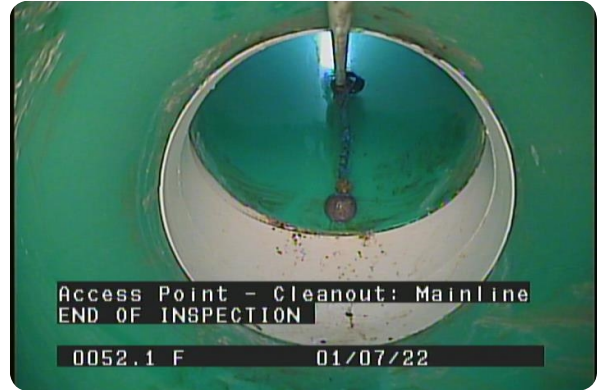
Access Point - Cleanout: Mainline at 052.1 feet | END OF INSPECTION
