Pipeline Inspection Report

Project: JUNCTION CITY COMMERCIAL
Work Order:
Survey Customer: WAY TO GO CONST.
PO Number:
Additional Info: 1INCH GRADE BALL & 8" MANDRELL

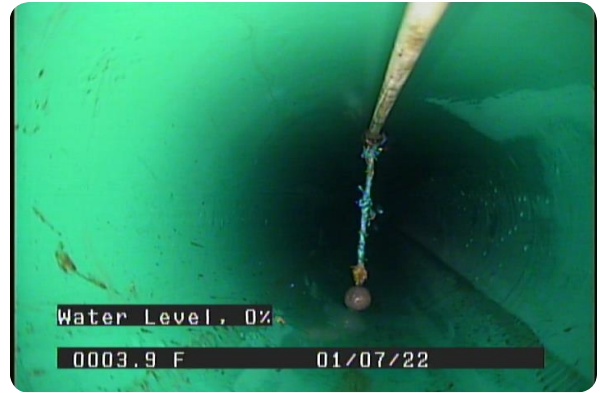
AutoSave: MWL@000.0ft (2).jpg

Access Point - Manhole at 000.0 feet | STARTING INSPECTION AT MH 01 GOING UPSTREAM TO CLEAN OUT
